# Shiawassee Capital Improvement Plan Project Examples

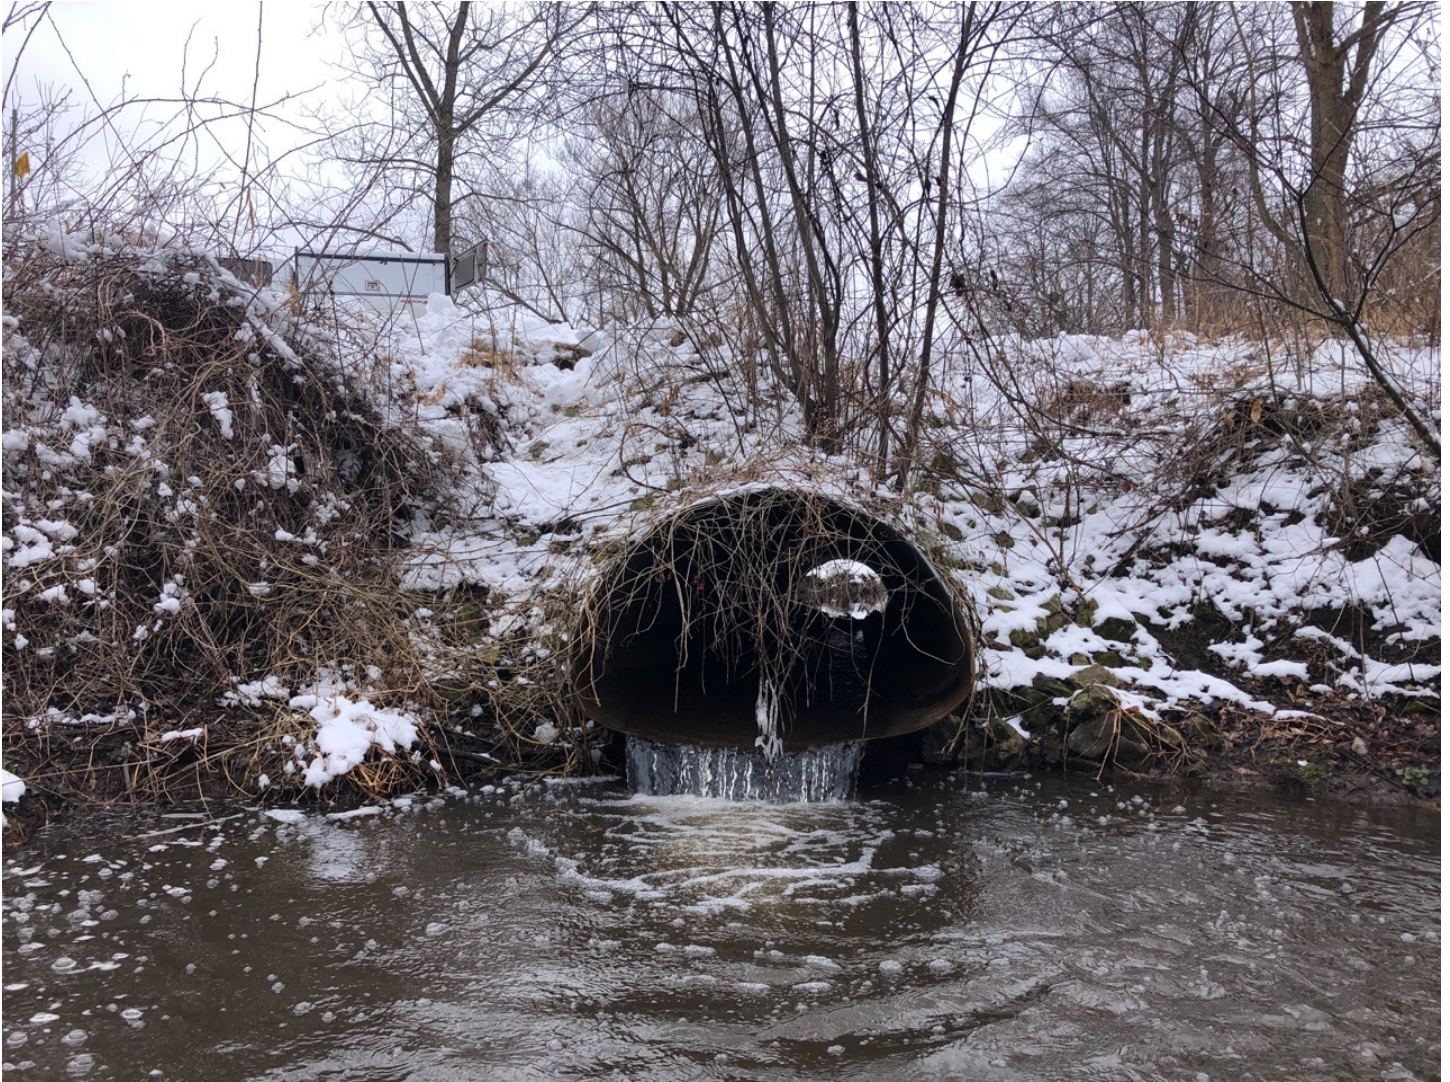
## Perched Culvert

The picture depicts a perched culvert. Perched culverts carve out, or scour, a basin below the impact point of the falling water. This has numerous detriments to the drainage system such as hindering wildlife travel upstream, increased erosion, and possible eventual collapse of the dirt supporting the culvert.

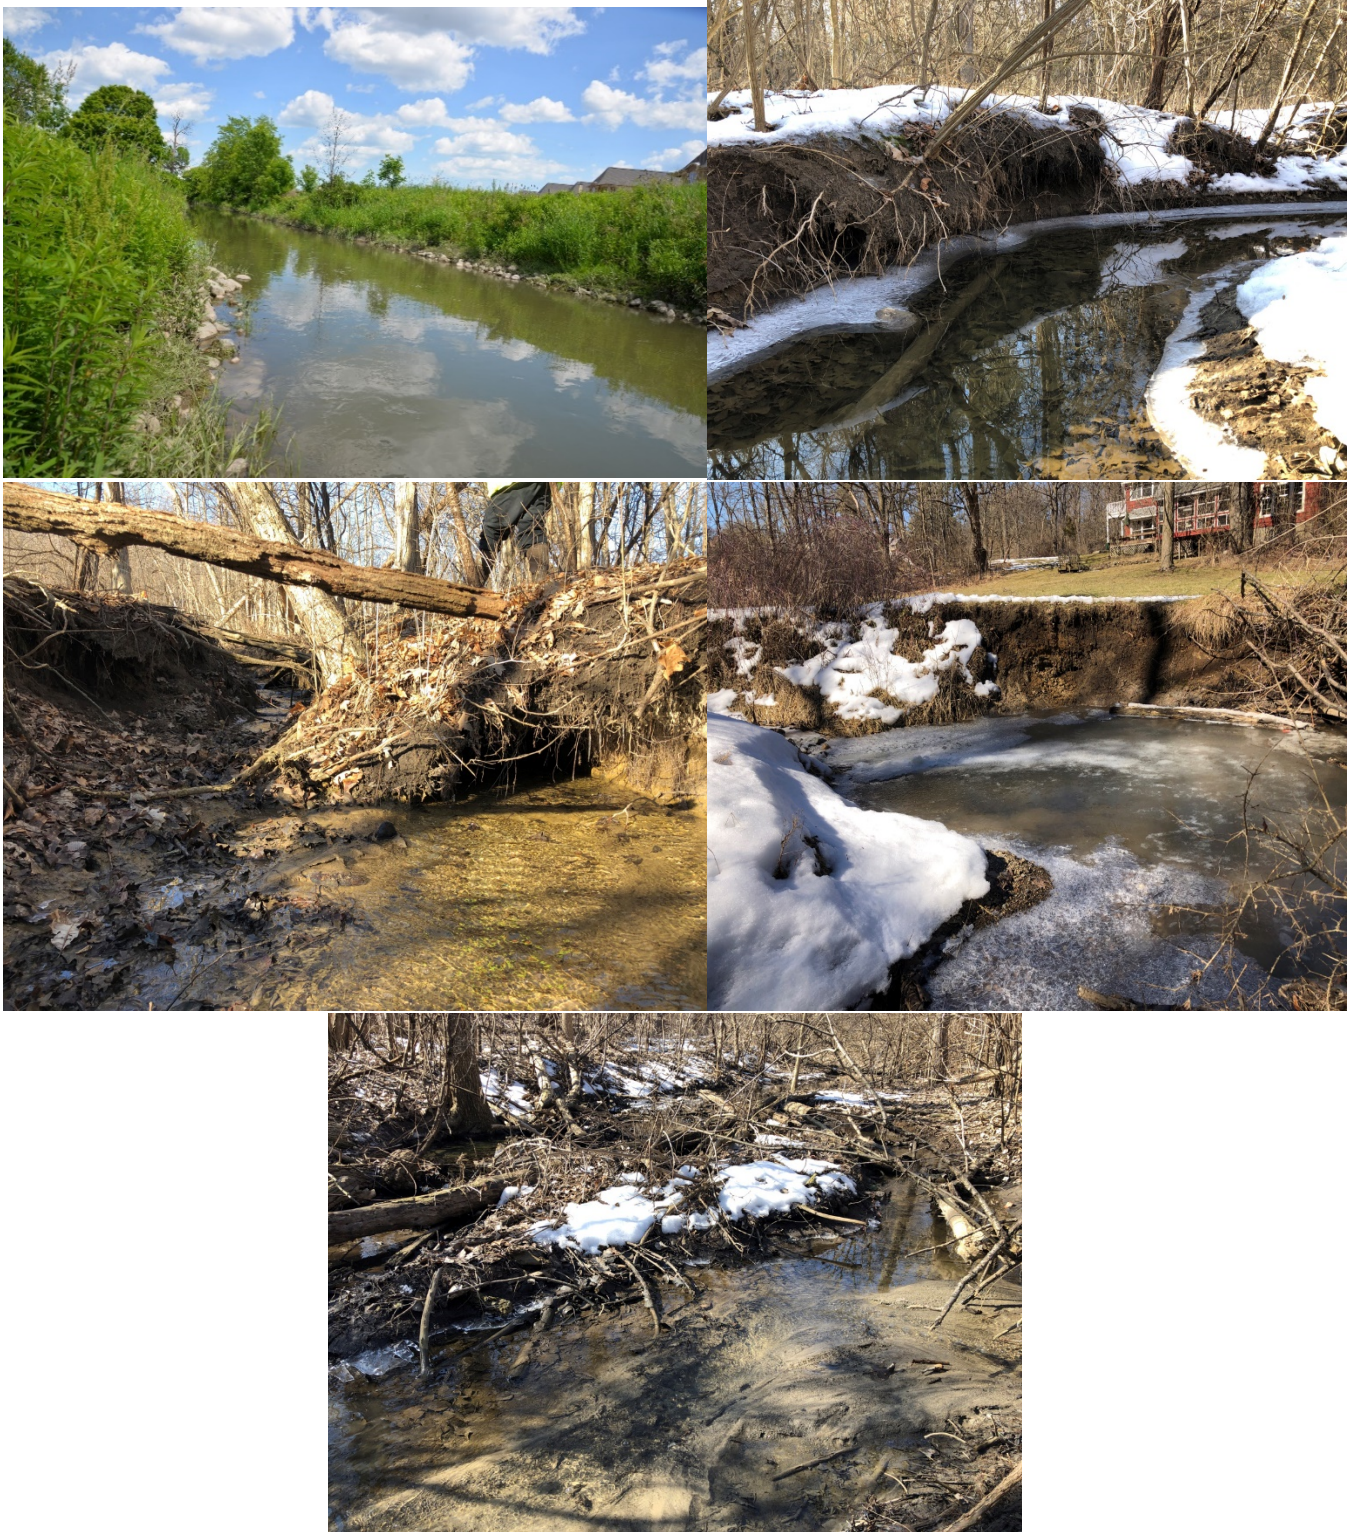
## Bank Erosion

These are pictures of drains with considerable streambank erosion along the watercourse. This disrupts water quality and sends sediment downstream where it can contribute to blockages, as shown by the sediment bar in the bottom photo. This can be rectified by stabilizing the bank such as shown in the top left photo. Remediation projects on eroded drains can have many benefits such as improving water quality and creating habitat for native wildlife.

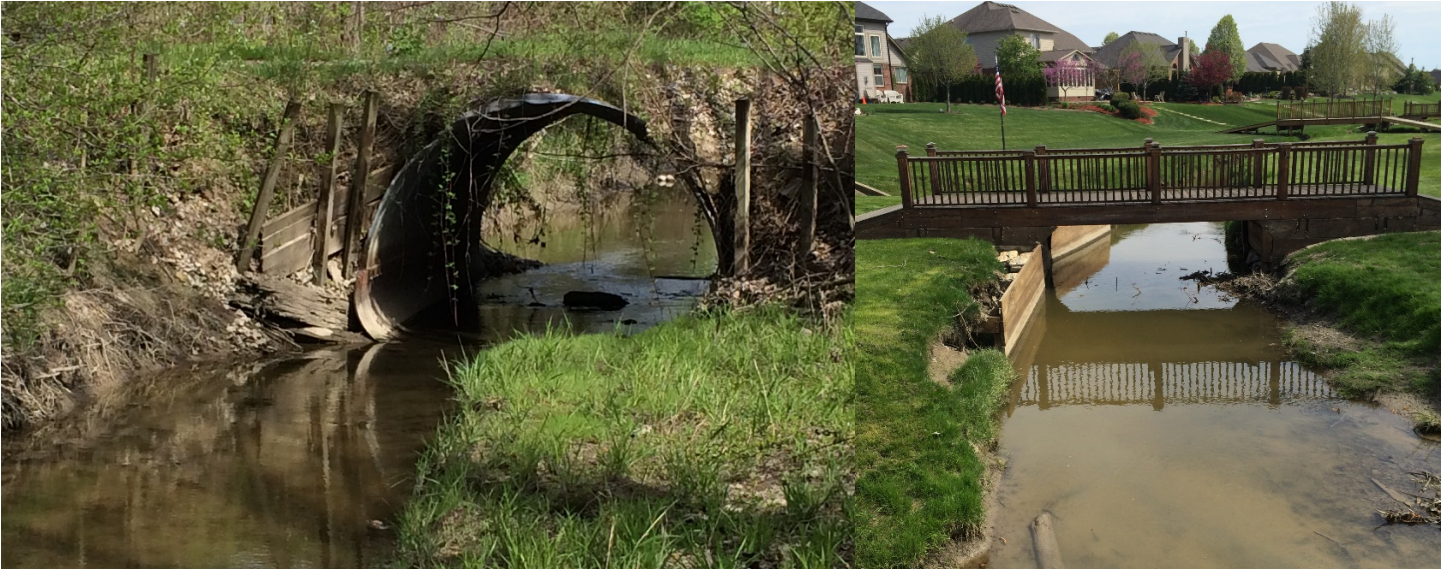
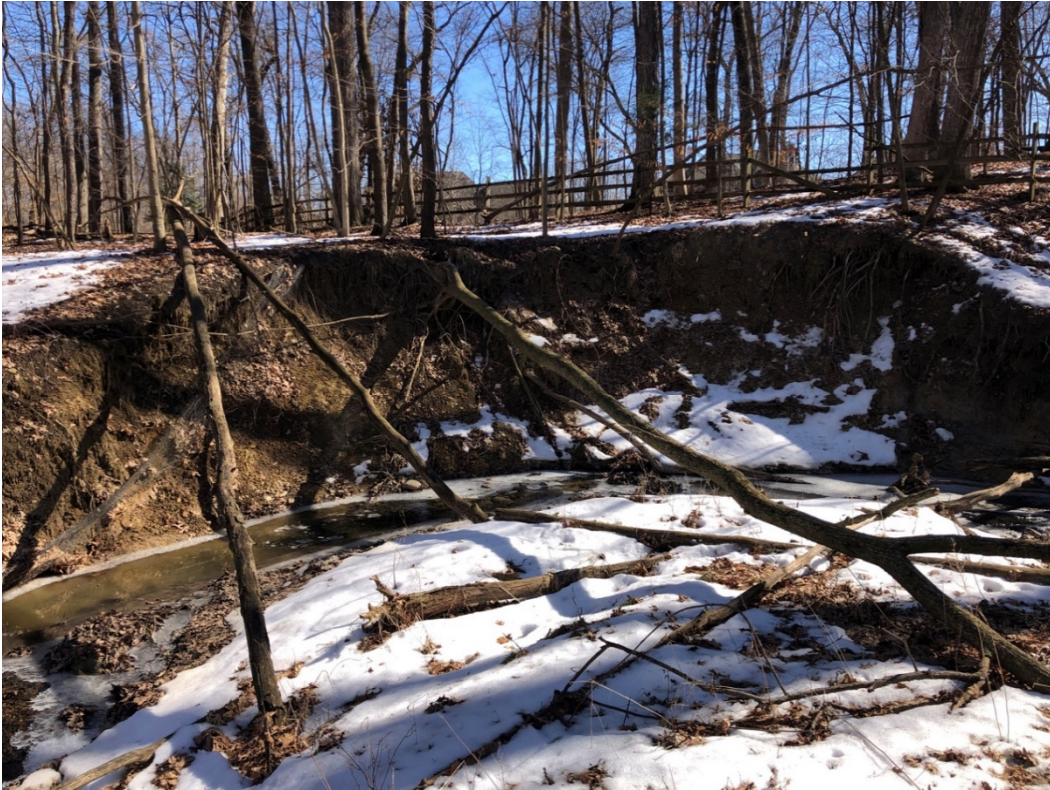
## Compromised Infrastructure

These are photos of typical drains running through urban and suburban areas. All of these photos show evidence of bank erosion that is threatening the integrity of established infrastructure. The erosion in the top right photo indicates the integrity of the bridge may become compromised if left unchecked. The top left shows a culvert whose dirt and wood supports could collapse if they are not fortified. The bottom photo shows an eroded bank closing in on a fence.

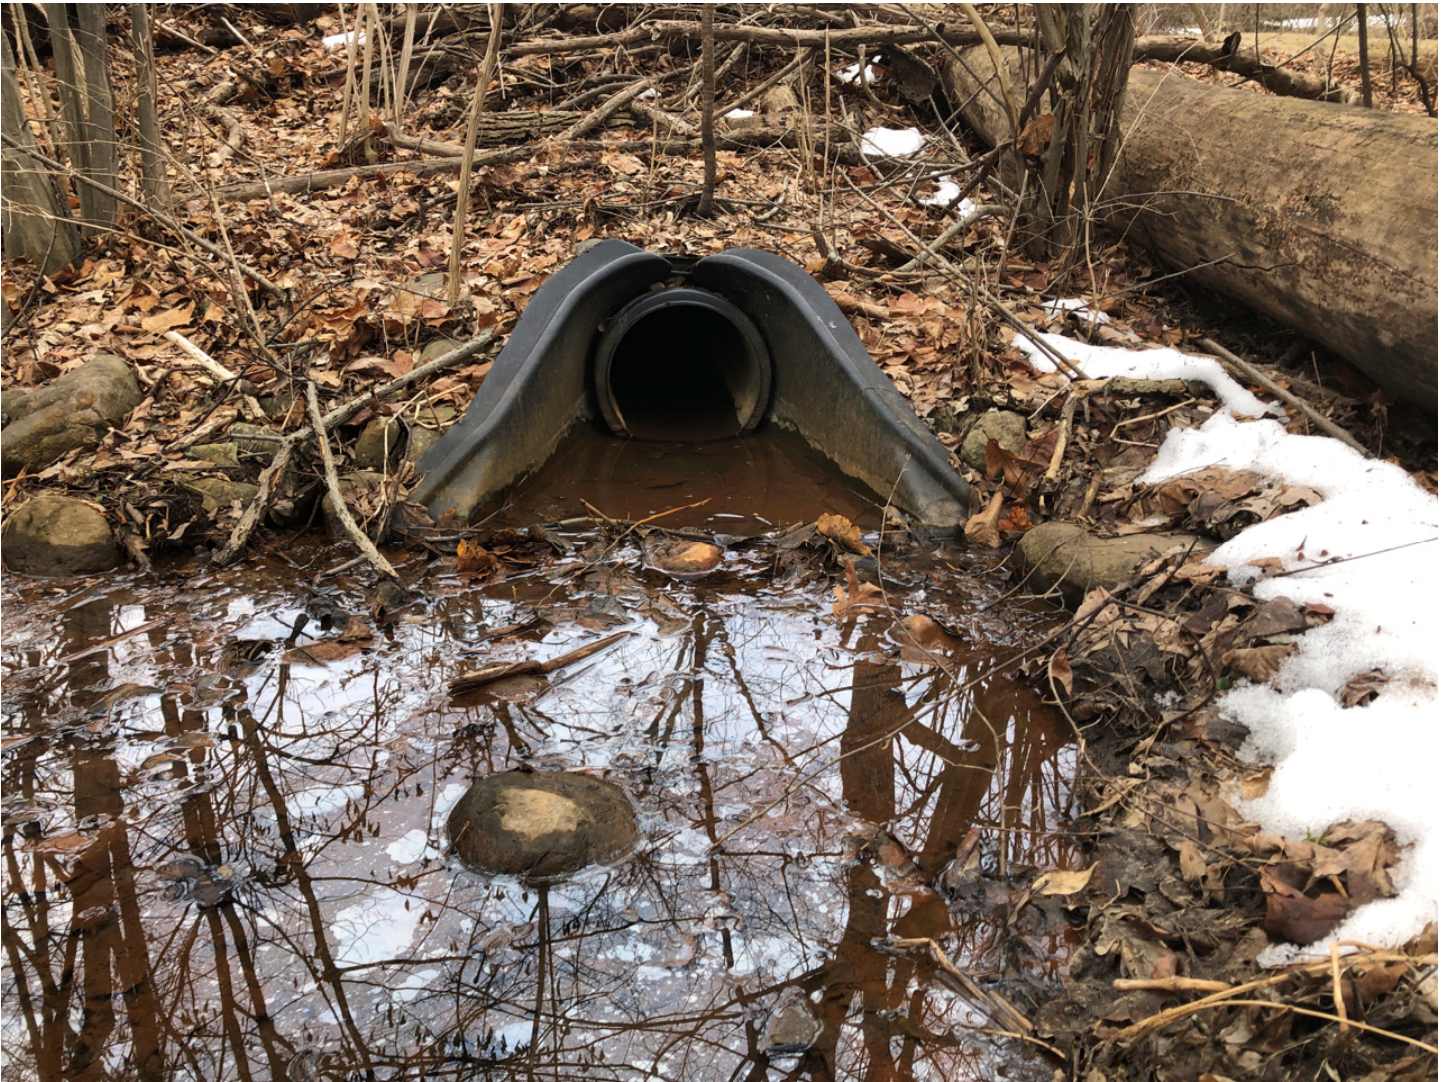
## Surface Pollution

This is a surface outlet pipe discharging into a drain. Notice the pollution on the surface of the water creating an oil-like sheen. This degrades water quality and is detrimental to organisms that depend on this water body. It would be beneficial to determine if the source of this pollution was a one-time event or if it is a constant problem at this location.

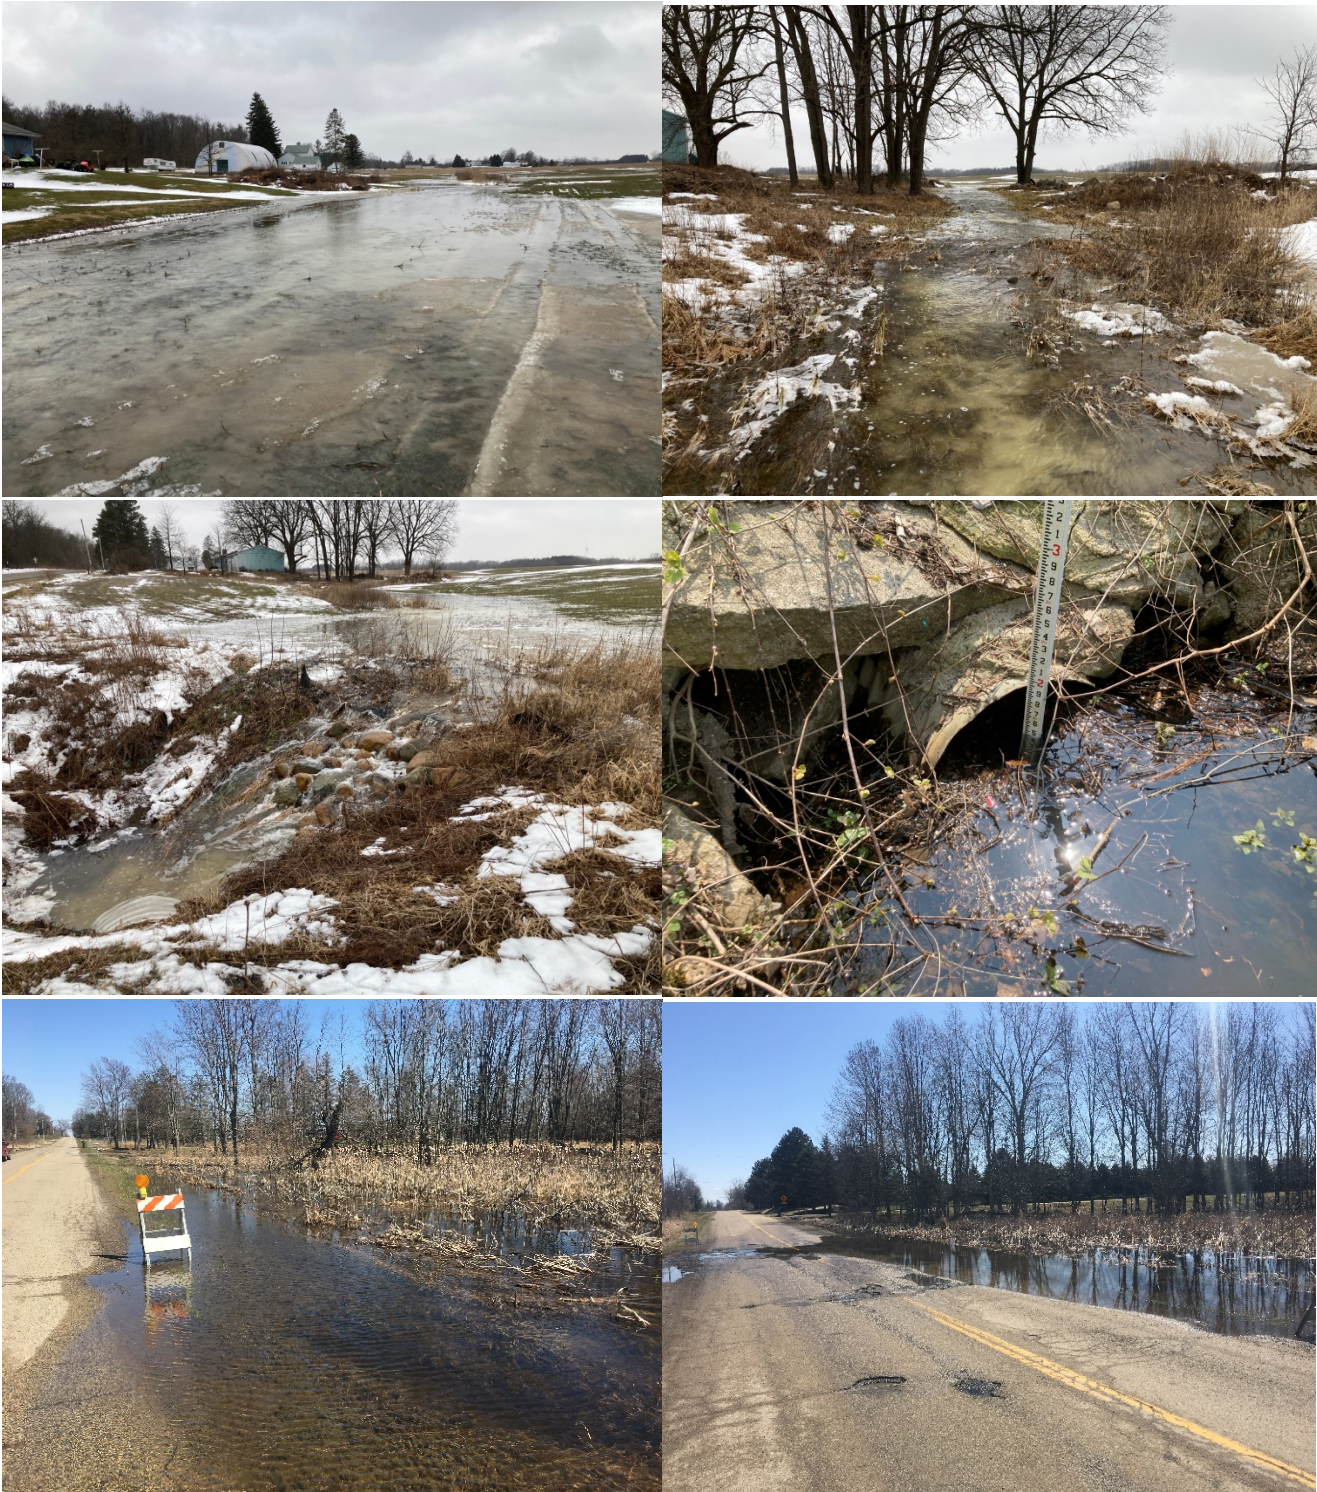
## Flooded Drain

These are examples of flooded drains in a rural areas. The center left and top two are a tile drain system that is flooding, with the water completely bypassing the intended storm system and entering the drain through culvert road crossings. The main branch supporting the tile drain likely needs to be widened to improve capacity or checked for blockages downstream. The center right shows a culvert crossing where the flow is very low, likely due to a change in grade or blockage downstream. The bottom two photos show a flooded drain overflowing onto a road.
